As part of the Windrush Recovery Project

ROAD RUN OFF IN THE UPPER WINDRUSH CATCHMENT

APPENDIX 3 Road run off Critchford Lane, Kineton

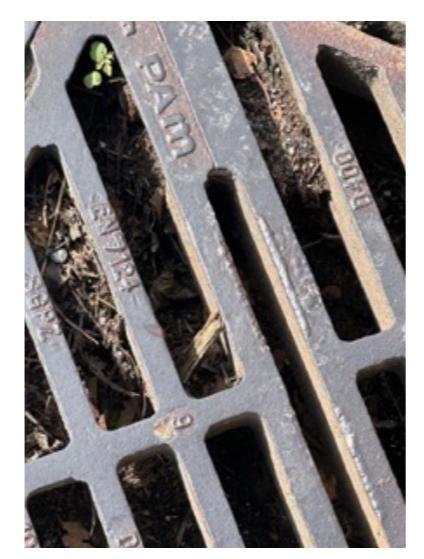
Figure 1 – Blocked gully adjacent to the Dikler, Upper Swell

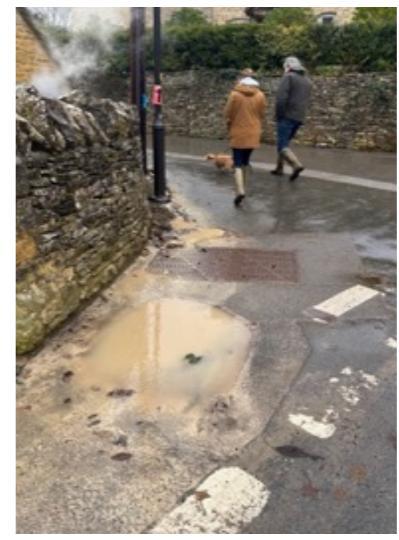
Figure 2 - Blocked gully in Naunton

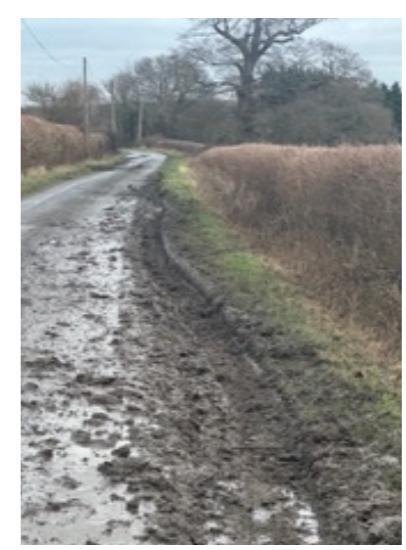
Figure 4 – Saturated drainage grip in Lower Swell

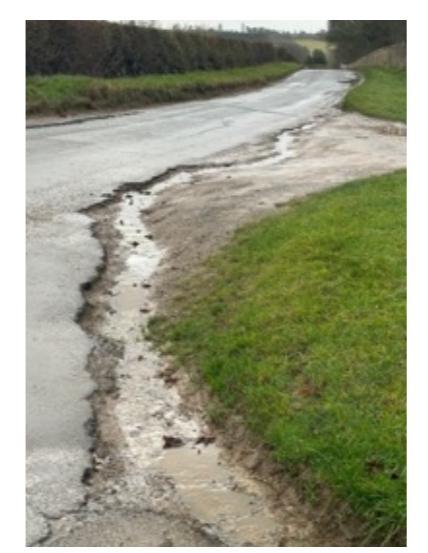
Figure 7 – Gully formed along road side at Ford

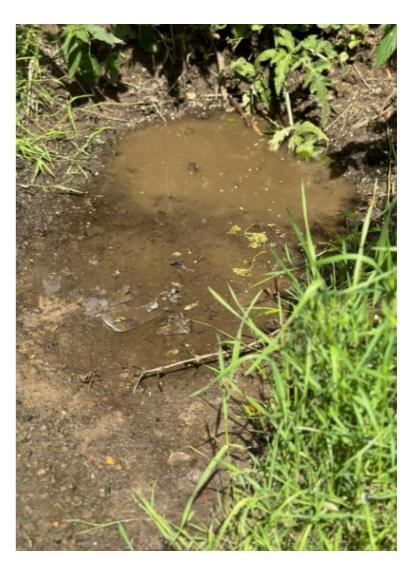
Figure 3 – Saturated drainage grip in Lower Swell

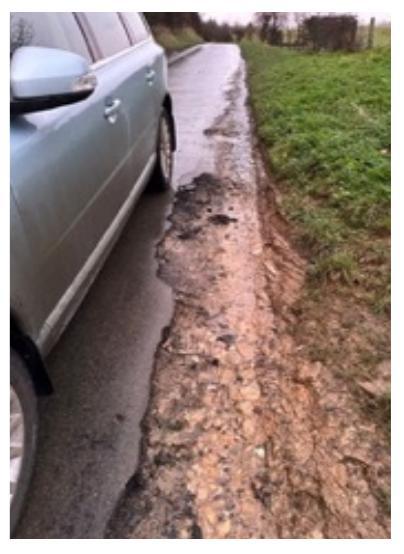
Figure 6 – Gully formed along road side near to Naunton

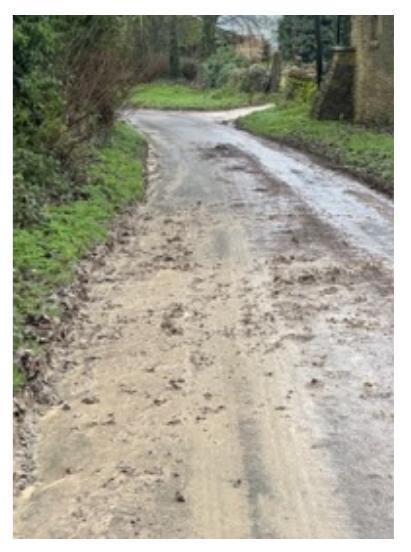
Figure 9 – Mud on road near to Naunton

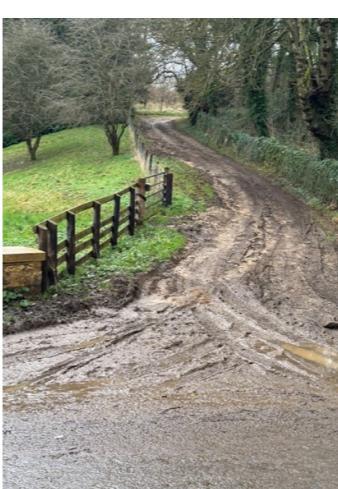
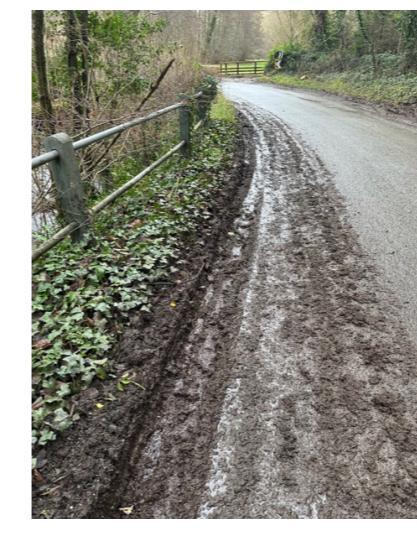
Water was seen running down the steep road which enters Barton and discharging into a gully that flows straight into the Windrush. The water contained significant quantities of sediment which derived from the saturated and cut up verges adjacent to the road.

Additionally, water carrying sediment was also noted to be running along a muddy farm track opposite the bridge for approximately 100m before entering the road gully.

Road run off – Tackling the road run off would require grips to be dug across the verge to allow the water to drain from the road. Feasibility – There is unlikely to be space to create an attenuation area for the road run off because the river runs directly below the road on one side and there is an incised verge on the other.

Damaged verged – Cleaning up the mud verge and extending the length of the existing kerb would reduce the saturation of the verge and reduce the amount of sediment washed down stream by the any road run off. It might be of benefit to install a kerb on the opposite side of the road. Feasibility – Further investigation of the quantity of run off is recommended and liason with the local authority should be undertaken.

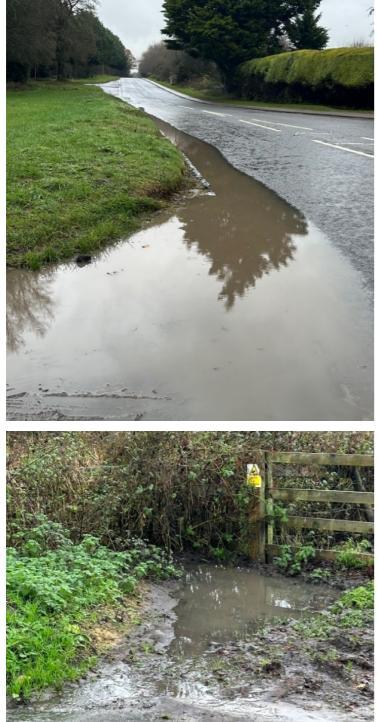
Additionally, water was seen running down Buckle Street which joins the water running along the Fosse Way about 30 metres prior to where it discharges into the Windrush.

The Fosse Way is the busiest road in the UWC, meaning the possibility of vehicle pollution in the road run off is high risk.

Road run off - To reduce run off from both the Fosse Way and Buckle Street grips need to be dug and maintained across the verge to ensure water and pollutants can drain from the road before hitting the Windrush.

Feasibility - The woodland on the corner of the Fosse Way and Buckle Street is well-sited for the creation of an attenuation area. Further investigation of the quantity of run off and holding capacity of the woodland would be required, additionally dialogue with the landowner and the local authority would be required.

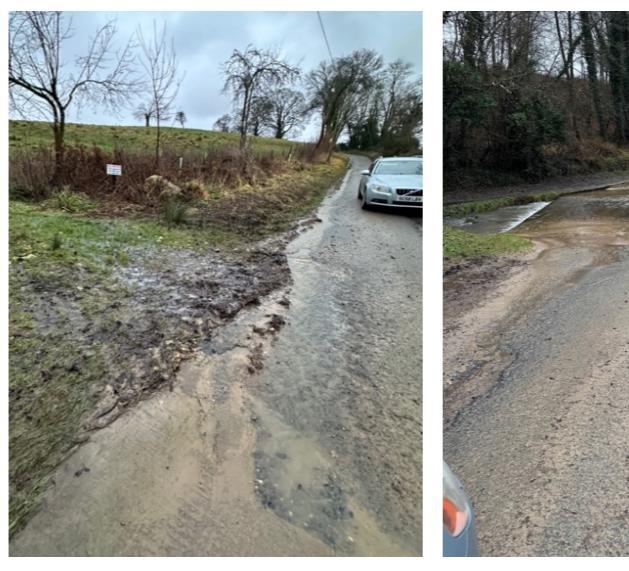
Two separate sources of run off were identified at this location. Firstly, run off from rainfall falling directly onto the road and secondly field run off from a gateway located 20m above ford. The run off collects sediment from the damaged verge edges and discharges directly into the stream.

Both sides of the road are badly eroded by run off suggesting this is a long-term issue. A concrete gully has been installed to one side of the road to divert water into a ditch adjacent to the ford. The ditch does not have adequate capacity to contain the runoff during periods of heavier rainfall.

Road run off - Diverting the water that reaches the road will be critical to reducing the run off that discharges into the ford. This could be undertaken by enhancing the gully or digging grips. Feasibility – The road is heavily incised meaning that it could be a challenge to create new grips to divert the run off. Further investigation should focus on determining the specific source of the run off.

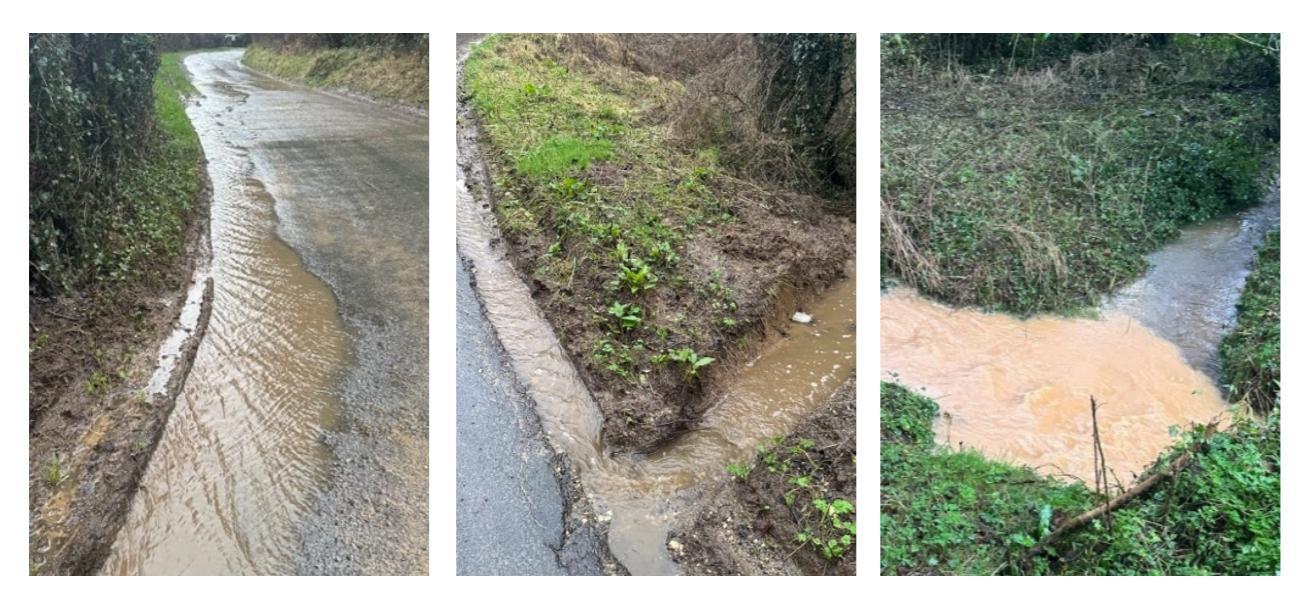
APPENDIX 4 Road run off Cutsdean

The volume of the road run off at this location is increased by water discharging from a spring 50 m above the discharge point and water running onto the road from adjacent fields.

The sediment in the road run off caused strong cplouration and highnturbidity of the water discharging into the river.

Road run off – Slowing down the water running off the road and reducing the volume could be achieved by digging additional grips higher up the road and diverting it into the ditch. Routine maintenance and clearance of the existing grips is essential to prevent them blocking.

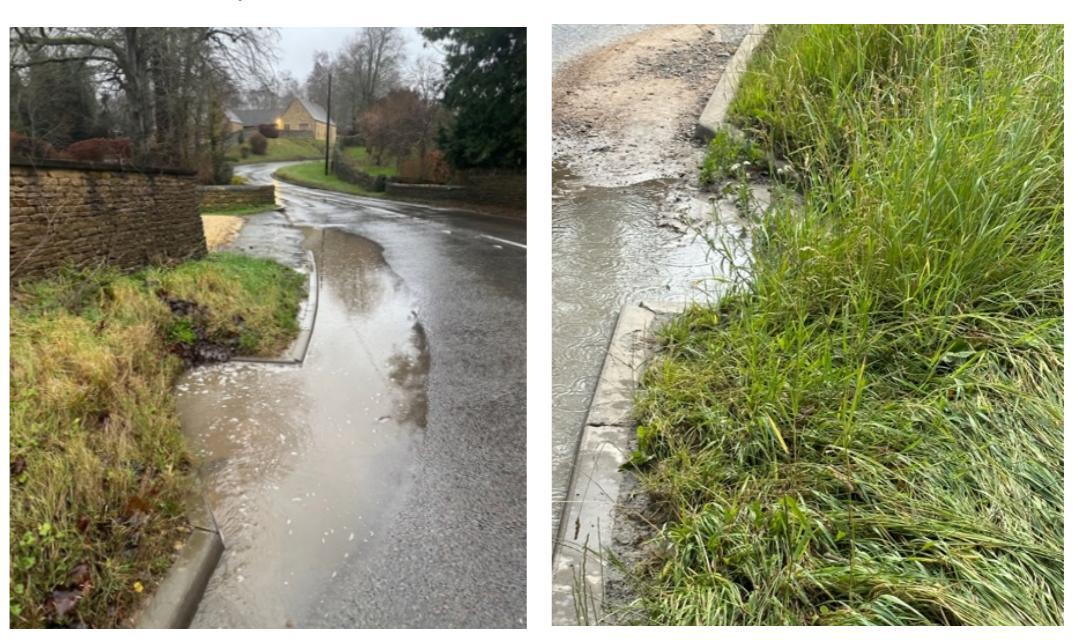
Road run off was seen tracking down steep hill until it reaches the bridge crossing over Windrush where it discharges into the river via a series of three gullies. The road was reported by local residents to be frequently flooded when the gullies and drains block up with sediment and organic matter.

The frequent flooding will be damaging the road surface and the location of the pooling water on a bend at the bottom of a steep hill creates a risk to road users.

Drain maintenance – Regular and ongoing clearing of the drains will reduce flooding issues on road **Feasibility** – The matter was raised with the local authority and it is hoped a new regime of regular maintenance will be undertaken.

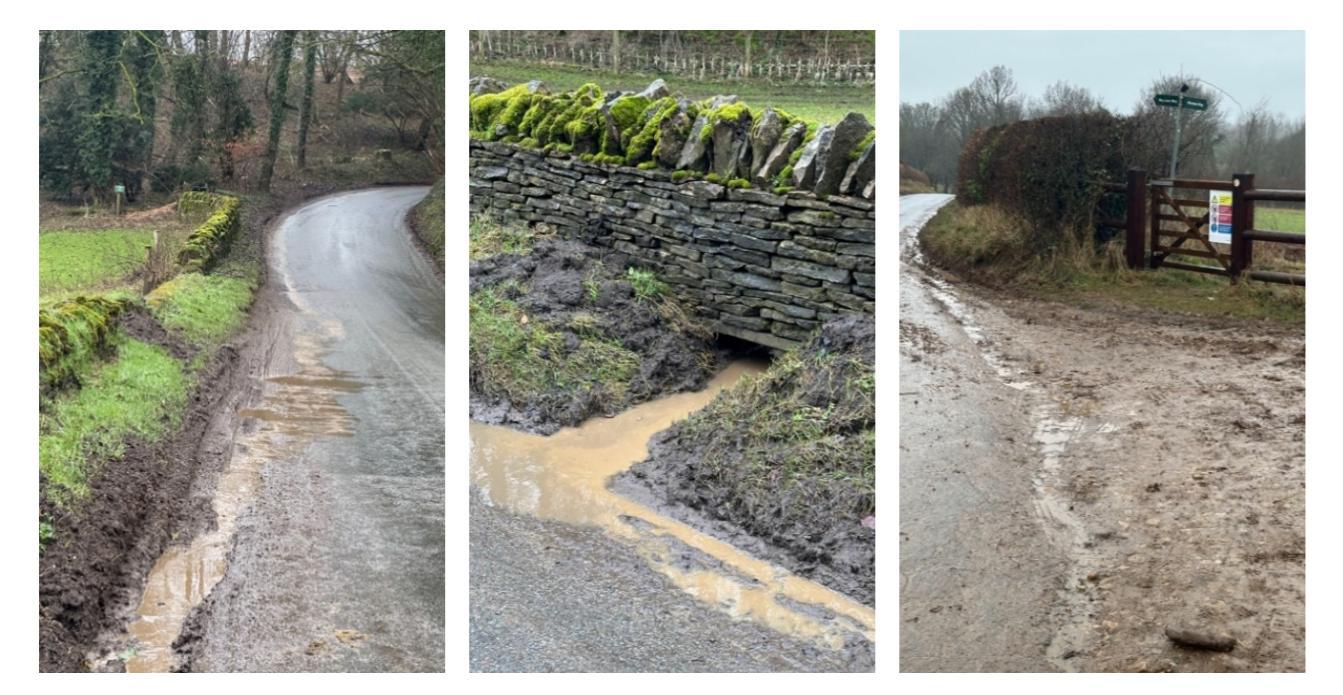
Water was seen running down a long stretch of steep road before draining through a series of roadside grips which directs the water into an area of pasture.

The water was carrying significant volumes of sediment derived from damaged roadside verges and field run off washed onto the road from a gateway located 200m uphill of the discharge point.

Field entrance – Reducing the sediment and gravel derived from the field entrance further up the hill could be achieved through the installation of hard standing and a cross drain at the field entrance and possibly digging more grips to drain water off the road.

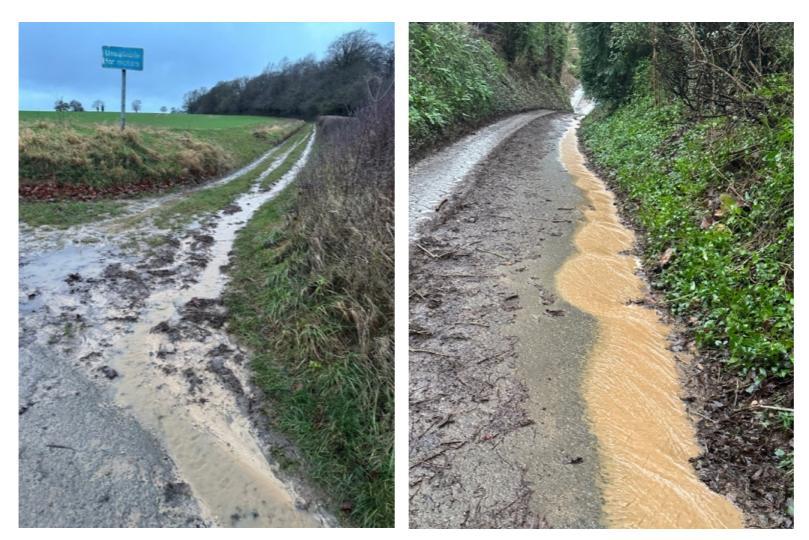
The run off was causing significant discolouration to the water in the river channel.

A Farm track run off – Planting a hedgerow and establishing a rough grass margin along the edge of the track will help slow the run off of water and sediment from the fields. The installations of cross drains along the track and new ditches would reduce the amount of water that is able to reach the road.

Feasibility – Further investigation of the quantity of run off and modelling of interventions should be done. Communication with the landowner, as part of the Catchment Sensitive Farming programme, should be undertaken.

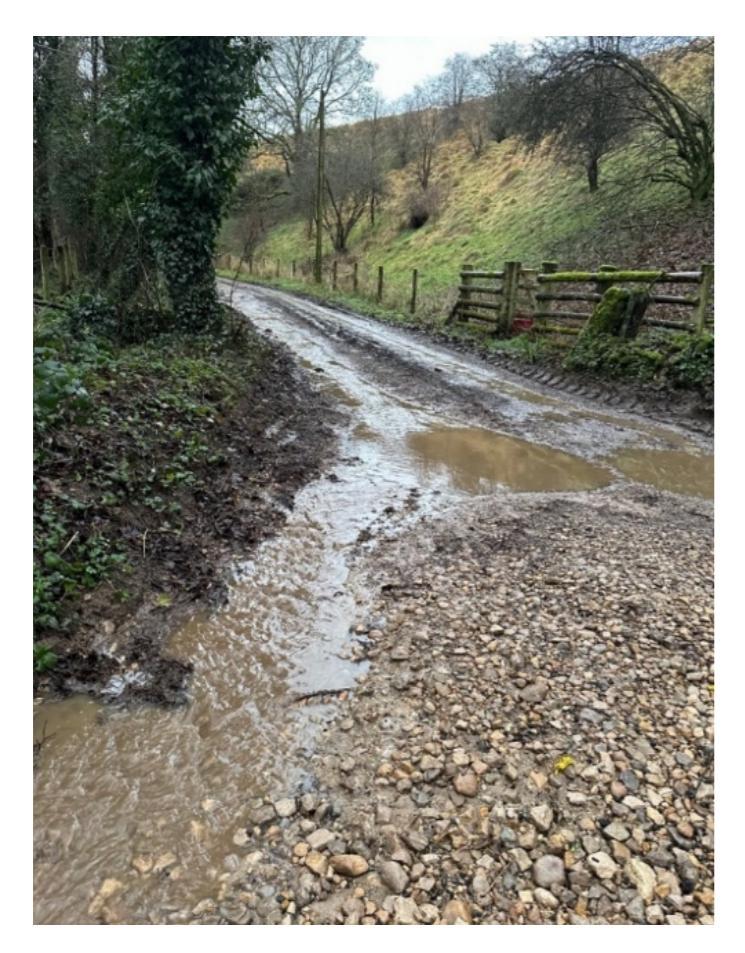
APPENDIX 8 Road run off Kineton 2

Water was seen to run off along an unmade track which transects the Windrush at a ford crossing. The track allows access for vehicles and is also used by horse riders and cyclists. An area of tarmac had been laid to divert the water into an attenuation area to the side of the track, but this was heavily eroded and broken down.

Farm track run off – Repair to the surface of the track, particularly where it crosses the river at the Ford should be undertaken. Cross drains could help to reduce the amount of run off and sediment that is washed directly into the river. Feasibility - Further investigation of the quantity of run off and modelling of interventions, and communication with the landowner as part of the Catchment Sensitive Farming programme, should be undertaken.

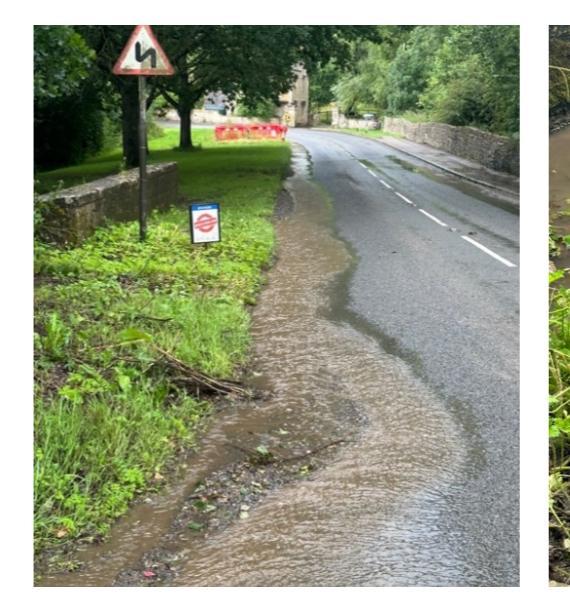
Significant volumes of water was seen flowing down the edge of the road. Water derived from rainfall on the road is increased in volume as a result of springs adjacent to the road discharging water when ground water levels are high. The water was carrying sediment from damaged verges and road grit which discahrges directkly into the Dikler.

The water pooling on a sharp bend at the bottom of the hill creates a risk to road users.

Road run off – Reconnect the culvert to the attenuation area and ensure it is kept free from sediment and organic litter that can block it.

Feasibility - **COMPLETE** – Following the project officers and local community raising their concerns work has been undertaken to ensure the culvert works and water cannot flow directly into the watercourse.

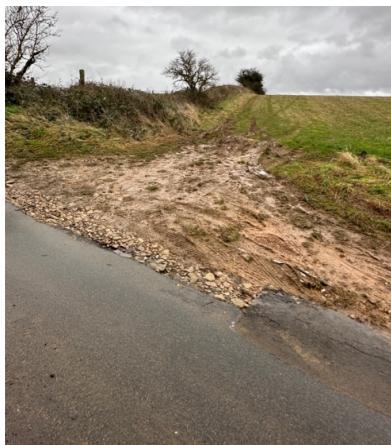
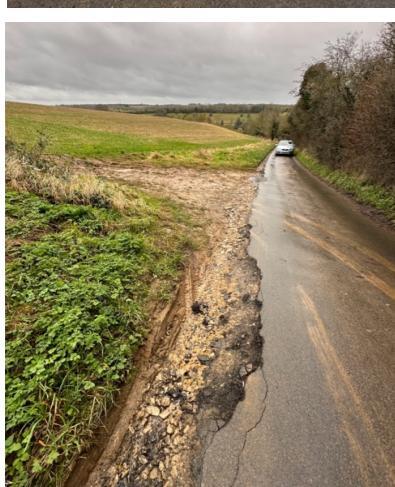
APPENDIX 10 Road run off Naunton 1

Water was seen running down the edge of a badly degraded single track road which slopes downhill into the village of Naunton. The water came from rainfall and run off from an agricultural track. The run off contained sediment from the verge, road grit from the damaged road surface and sediment from the adjacent fields and tracks.

The water runs along the road for another 500m before entering a series of three drains which discharge directly into the Windrush.

Road run off – There is an opportunity to divert the water away from the road by draining it into the adjacent woodland or agricultural field. Planting a hedgerow adjacent to the road and establishing a rough grass margin would help slow and divert water decreasing the amount or run off discharging into the Windrush at the bottom of the hill. Feasibility - Discussion between local highways and farming interests could see the landowner take up an Environmental Land Management schemes such as margins and hedgerow creation to create attenuation areas to relieve road run off.

Field entrance – Installation of hard standing and a cross drain at the entrance to the arable field would help minimise the erosion and associated sediment and gravel run off.
Feasibility - Further investigation of the quantity of run off and modelling of interventions would be beneficial to identify the most suitable interventions. Communication with the landowner as part of the Catchment Sensitive Farming programme should be undertaken.

Drains – The drains at the bottom of the road were completely blocked with sediment and debris causing localised flooding in the village. Feasibility - Work completed at the top of the hill and the increased maintenance of the drains would reduce the occurence of flooding and damage to the road from standing water.

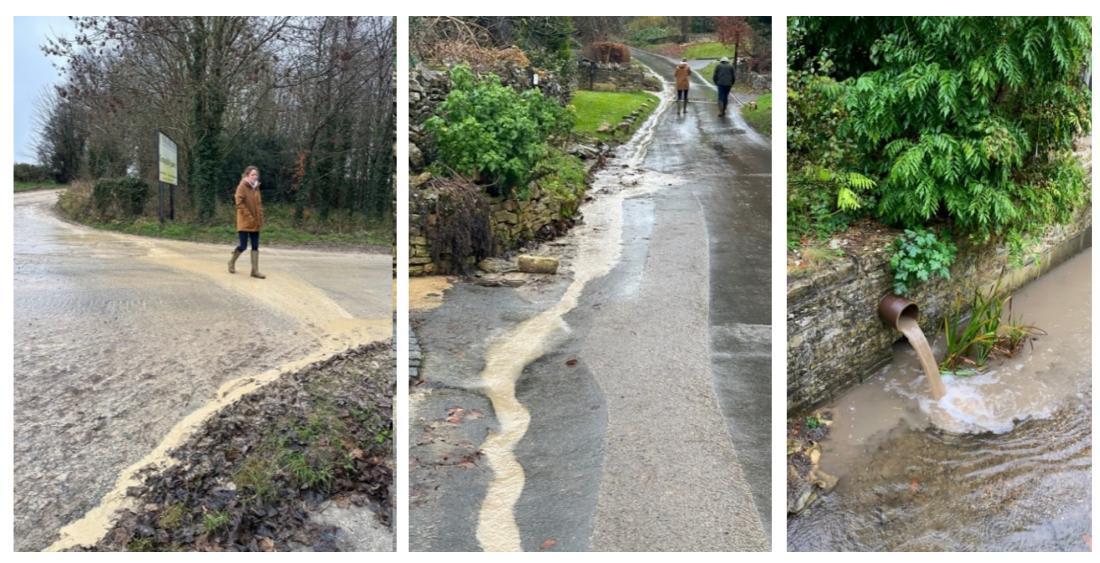
Large volumes of water and sediment were seen running from the entrance track to a local stone quarry. The water flowed downhill along the road for about 1km before entering drains that discharge directly into the Windrush.

Road run off - Diverting the water before it reaches the quarry entrance and road is a priority. There is an opportunity to have the water enter into the woodland on the edge of the quarry and to create an attenuation area which would act as a natural filter. Feasibility – COMPLETE – The issue was resolved within a month following it being raised with Highways Gloucestershire County Council and the Environment Agency who subsequently liaised with the quarry operators. When returning to the site, the entrance to the quarry had been cleaned and tarmacked. Water and sediment were still able to run off the hard standing but was now being diverted into the woodland via additional culverts which had been dug and enlarged.

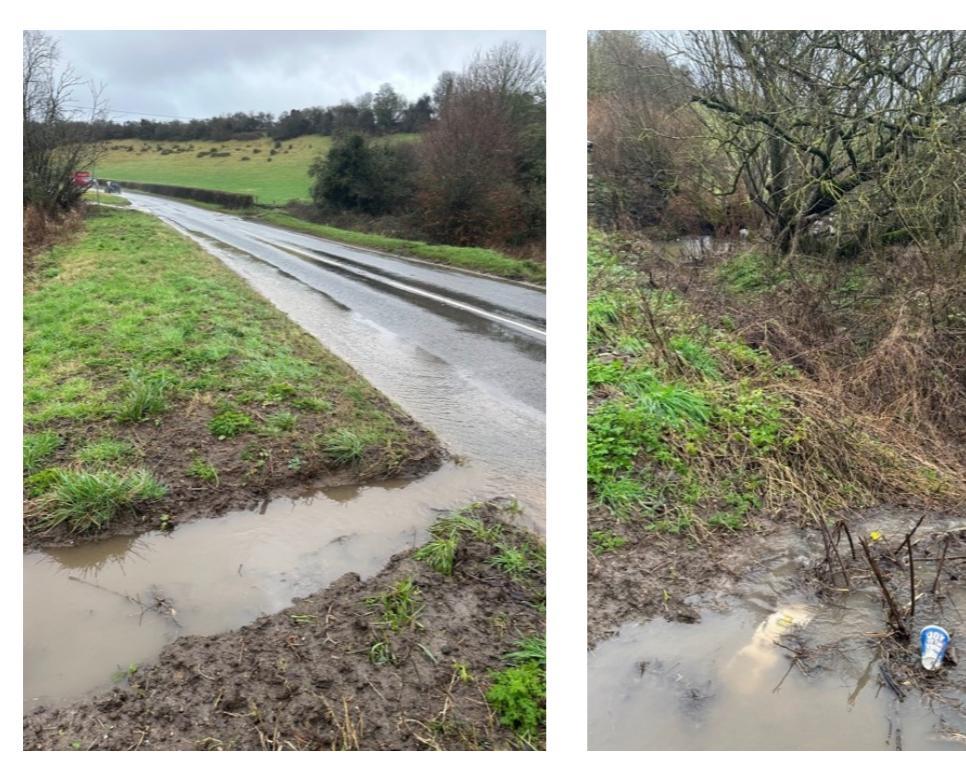
APPENDIX 12 Road run off Naunton 3

Water was seen running alongside a 3km stretch of road from the east and the west of the Windrush. The water diverts into a ditch adjacent to ta road bridge and is discharged directly into the Windrush. Litter was being transported by the water in the direction of the river.

Road run off - The creation of grips and regular clearance of the gullies further up the road would divert the water away from the road and limit the volume of road run off entering the watercourse. **Feasibility** - Further investigation and communication with the Local Authority and landowner is required.

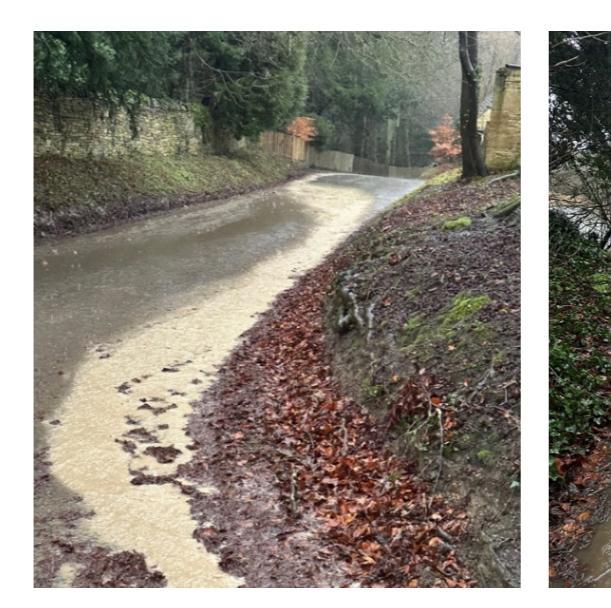
The driveway is constructed of hardcore which has broken down and results in large quantities of sediment in the water.

The significant road flooding on the road bridge was the result of the culvert becoming blocked with debris and organic matter. The large puddle on a bend presents a significant hazard for vehicles and other road users.

Private Driveway – Interventions should be focused on preventing the water ands ediment flowing onto the road. The incised nature of the road leading down to the bridge leaves few opportunities to divert the water off the road before the road crossing. The driveway could be resurfaced to reduce sediment run off, and cross drains could be implemented to drain the water away.
 Feasibility – Further investigation would be required to see who owns the driveway and what options are open to reducing the run off on to the road.

Grip Maintenance – Ensuring the drain to the bridge is kept clear at regular intervals would reduce the risk to drivers **Feasibility** – Discussions would be required with the local authority to secure further maintenance.

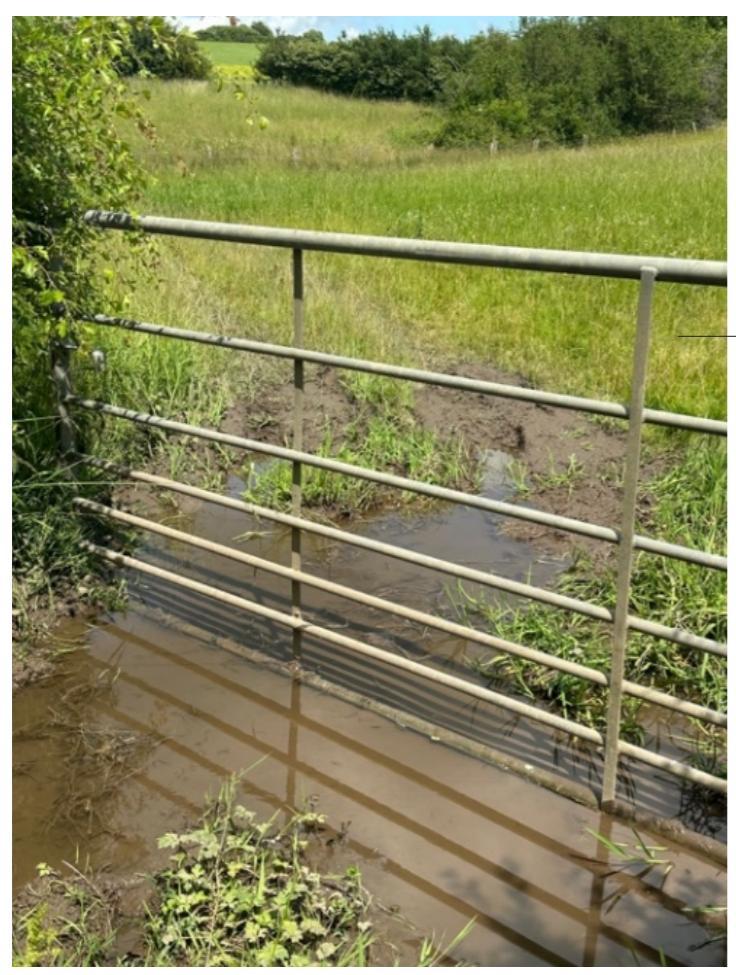
APPENDIX 14 Road run off Upper Swell

Spring fed field run off was seen emerging onto the road from a farm gateway. The water was picking up sediment before running across the road and discharging into theDikler via a culvert 100 metres downhill.

Field Entrance – The volume of spring water and sediment reaching the road and discharging directly into the waterway could be reduced if the gateway was repositioned ten metres up the field to move it away from the spring. Further monitoring would be required to ensure the spring water does not continue to flow onto the road. Feasibility - Further investigation of the quantity of run off and modelling of interventions, and communication with
