As part of the Windrush Recovery Project

ROAD RUN OFF IN THE UPPER WINDRUSH CATCHMENT

APPENDIX 3 Road run off Critchford Lane, Kineton

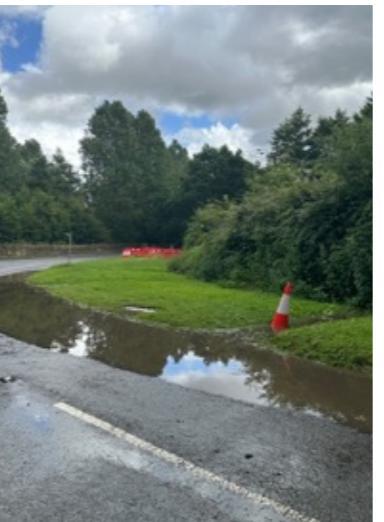
Figure 4 – Saturated drainage grip in Lower Swell

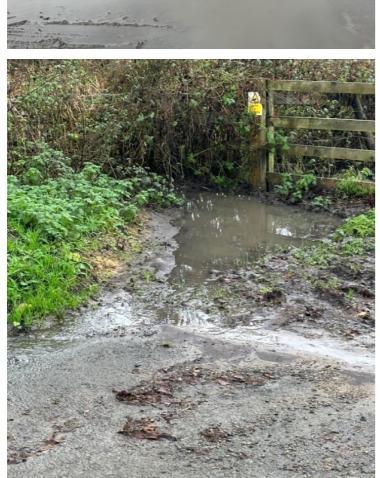
Two separate sources of run off were identified at this location. Firstly, run off from rainfall falling directly onto the road and secondly field run off from a gateway located 20m above ford. The run off collects sediment from the damaged verge edges and discharges directly into the stream.

Road run off - Diverting the water that reaches the road will be critical to reducing the run off that discharges into the ford. This could be undertaken by enhancing the gully or digging grips. Feasibility – The road is heavily incised meaning that it could be a challenge to create new grips to divert the run off. Further investigation should focus on determining the specific source of the run off.

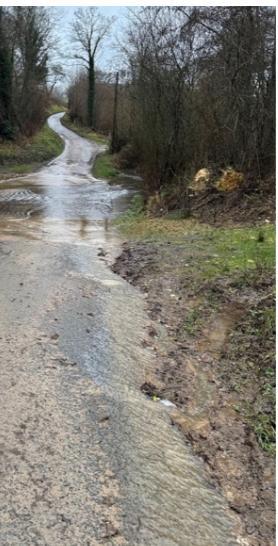
APPENDIX 4 Road run off Cutsdean

The sediment in the road run off caused strong cplouration and highnturbidity of the water discharging into the river.

The water was carrying significant volumes of sediment derived from damaged roadside verges and field run off washed onto the road from a gateway located 200m uphill of the discharge point.

A Farm track run off – Planting a hedgerow and establishing a rough grass margin along the edge of the track will help slow the run off of water and sediment from the fields. The installations of cross drains along the track and new ditches would reduce the amount of water that is able to reach the road.

Feasibility – Further investigation of the quantity of run off and modelling of interventions should be done. Communication with the landowner, as part of the Catchment Sensitive Farming programme, should be undertaken.

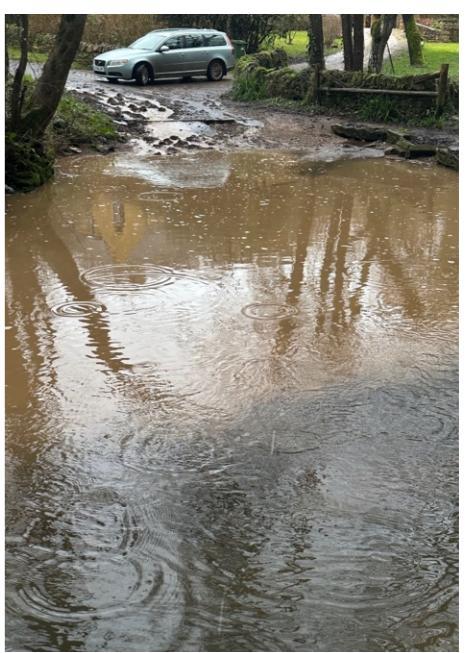
APPENDIX 8 Road run off Kineton 2

Water was seen to run off along an unmade track which transects the Windrush at a ford crossing. The track allows access for vehicles and is also used by horse riders and cyclists. An area of tarmac had been laid to divert the water into an attenuation area to the side of the track, but this was heavily eroded and broken down.

Farm track run off – Repair to the surface of the track, particularly where it crosses the river at the Ford should be undertaken. Cross drains could help to reduce the amount of run off and sediment that is washed directly into the river. Feasibility - Further investigation of the quantity of run off and modelling of interventions, and communication with the landowner as part of the Catchment Sensitive Farming programme, should be undertaken.

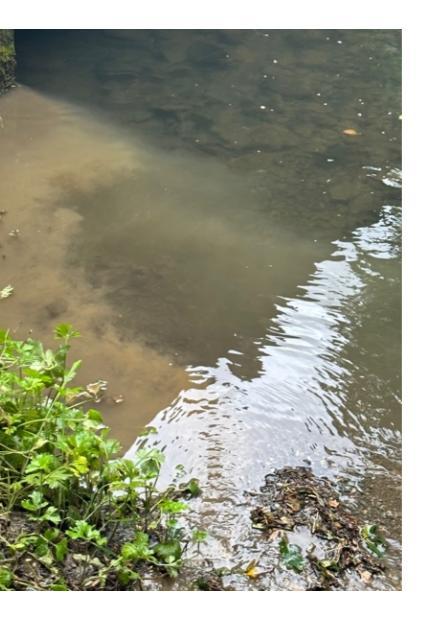
APPENDIX 10 Road run off Naunton 1

Water was seen running down the edge of a badly degraded single track road which slopes downhill into the village of Naunton. The water came from rainfall and run off from an agricultural track. The run off contained sediment from the verge, road grit from the damaged road surface and sediment from the adjacent fields and tracks.

Drains – The drains at the bottom of the road were completely blocked with sediment and debris causing localised flooding in the village. Feasibility - Work completed at the top of the hill and the increased maintenance of the drains would reduce the occurence of flooding and damage to the road from standing water.

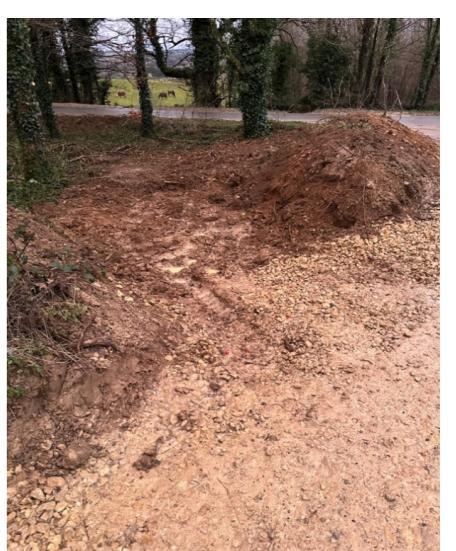
APPENDIX 12 Road run off Naunton 3

The driveway is constructed of hardcore which has broken down and results in large quantities of sediment in the water.

The significant road flooding on the road bridge was the result of the culvert becoming blocked with debris and organic matter. The large puddle on a bend presents a significant hazard for vehicles and other road users.

Private Driveway – Interventions should be focused on preventing the water ands ediment flowing onto the road. The incised nature of the road leading down to the bridge leaves few opportunities to divert the water off the road before the road crossing. The driveway could be resurfaced to reduce sediment run off, and cross drains could be implemented to drain the water away.
 Feasibility – Further investigation would be required to see who owns the driveway and what options are open to reducing the run off on to the road.

Grip Maintenance – Ensuring the drain to the bridge is kept clear at regular intervals would reduce the risk to drivers **Feasibility** – Discussions would be required with the local authority to secure further maintenance.
